FINAL REPORT

on investigation of the serious incident
of helicopter type **Eurocopter AS-355N**
reg. No. **OM-IKM**

Date: 23.09.2010

Place: Ružín dam

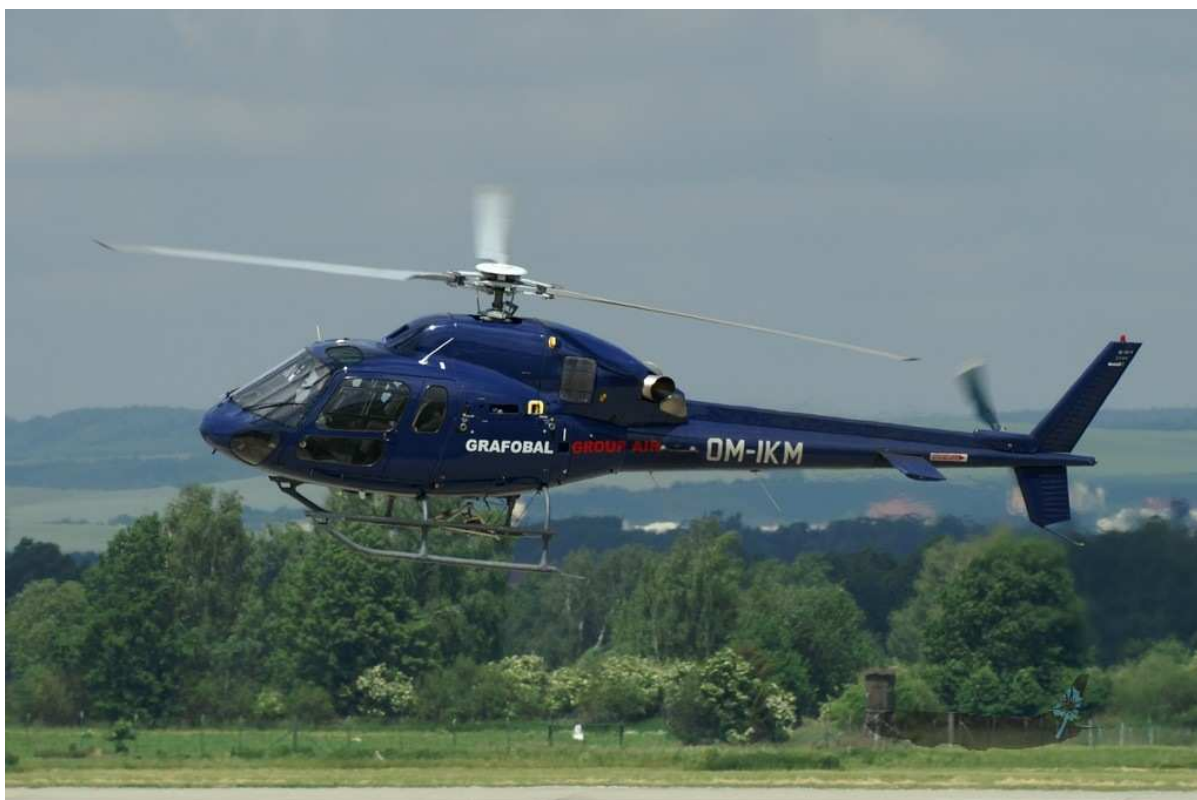
At 11:20 the instructor made an emergency landing on the nearest suitable ground near the Ružín dam without causing any further damage to the helicopter or injury to the crew. When the engines had stopped the helicopter crew detected damage to the anti-torque rotor.

The tail-rotor boom was slightly damaged by vibrations from the anti-torque rotor.

The anti-torque rotor of the helicopter was damaged and will have to be replaced.

The cause of the serious incident was the anti-torque rotor getting caught on a stone, which was not registered by the helicopter crew during ground landing training.
