FINAL REPORT

on the safety investigation of an air accident

of the aircraft type **Viper SD4 RTC**
registration mark **OM-VIP**

Reg. No.: **SKA2020002**

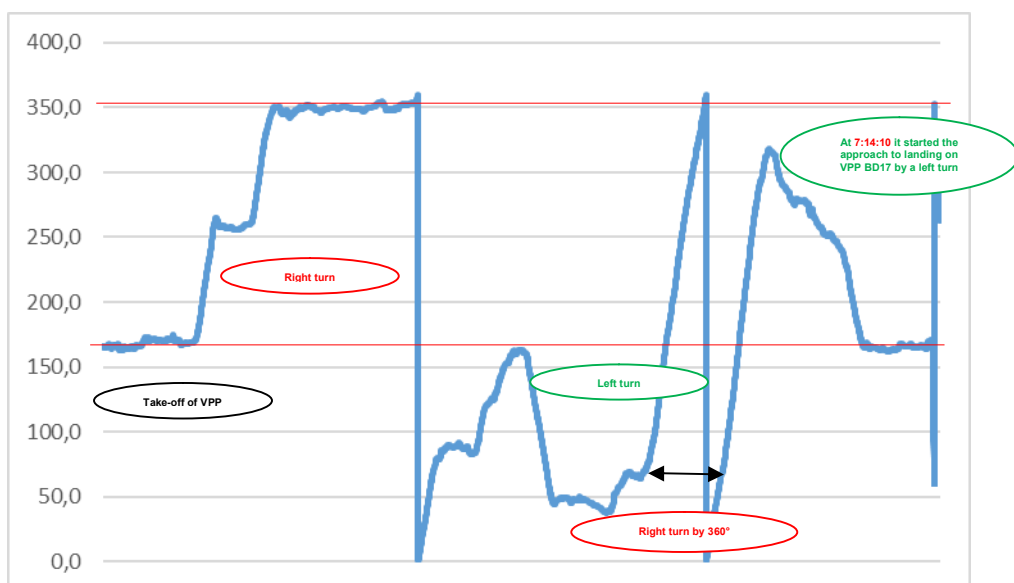
Heading course - 07:07:18– 07:16:46

At 7:14:10 it began to perform at a height of GPS ALT 2223 ft a turn to the left to approach landing above the village Čakanovce.
